BRIDGING THE GAP FOR BATS

Bat exclusion essential to bridge work

BY KARLA REEVE-WISE

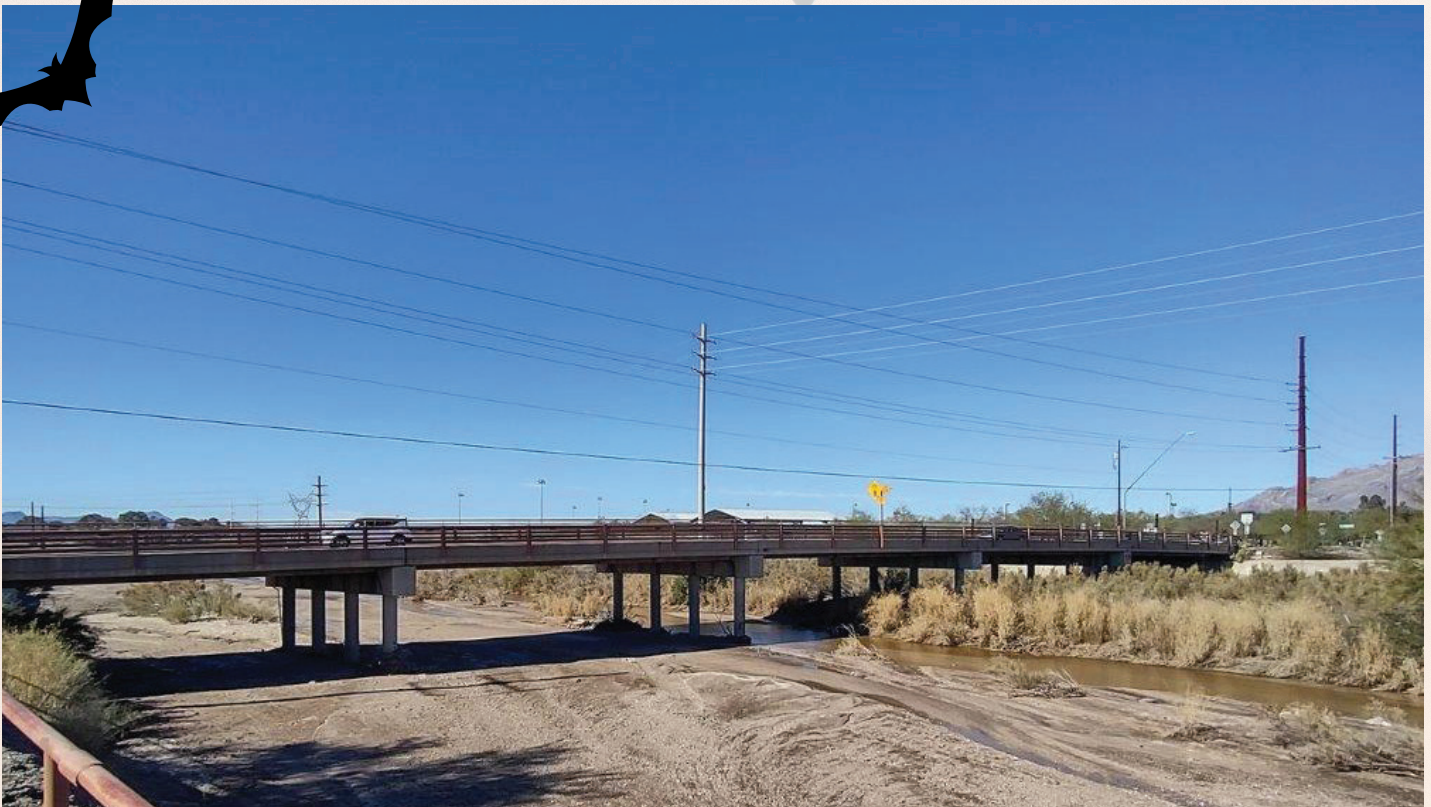
Dodge Road Bridge over the Rillito River, Tucson, Arizona.

In my transportation career, I have been exposed to many bridge projects as an environmental planner either directly or indirectly through coworkers' assignments, and several of these structures contained habitat for bats. The type of bridge usually associated with occupancy is the box beam girder bridge. I remember my first bridge project with bats had a colony of western pipistrelles (*Parastrallus hesperus*) living in it and was located at Dodge Road Bridge over the Rillito River in Tucson. It was a road maintenance project, and not only did we have to remove the bats, we also had to do it in a way that would allow the little creatures back into the crevices once the work was completed. It was a relatively small bridge but still a challenge because it was my first exposure to the bat exclusion process. We used backer rod and expandable spray foam to block the empty crevices. Some work occurred at night while the bats were out feeding. Once the exclusion work was completed, routine inspections had to occur because the movement and vibration of the vehicles passing over the bridge, the hot and cold expansion of the concrete bridge girders throughout the seasons, and the wind all can cause the exclusion devices to wiggle out of the crevices over time. On occasion, the backer rod had to be repaired and crevices rechecked to make sure bats had not reentered them. Once the work was completed, the backer rod and spray foam were removed, and the bats were allowed to reenter. No loss of habitat occurred, and it was satisfying to see the bats back in the bridge.

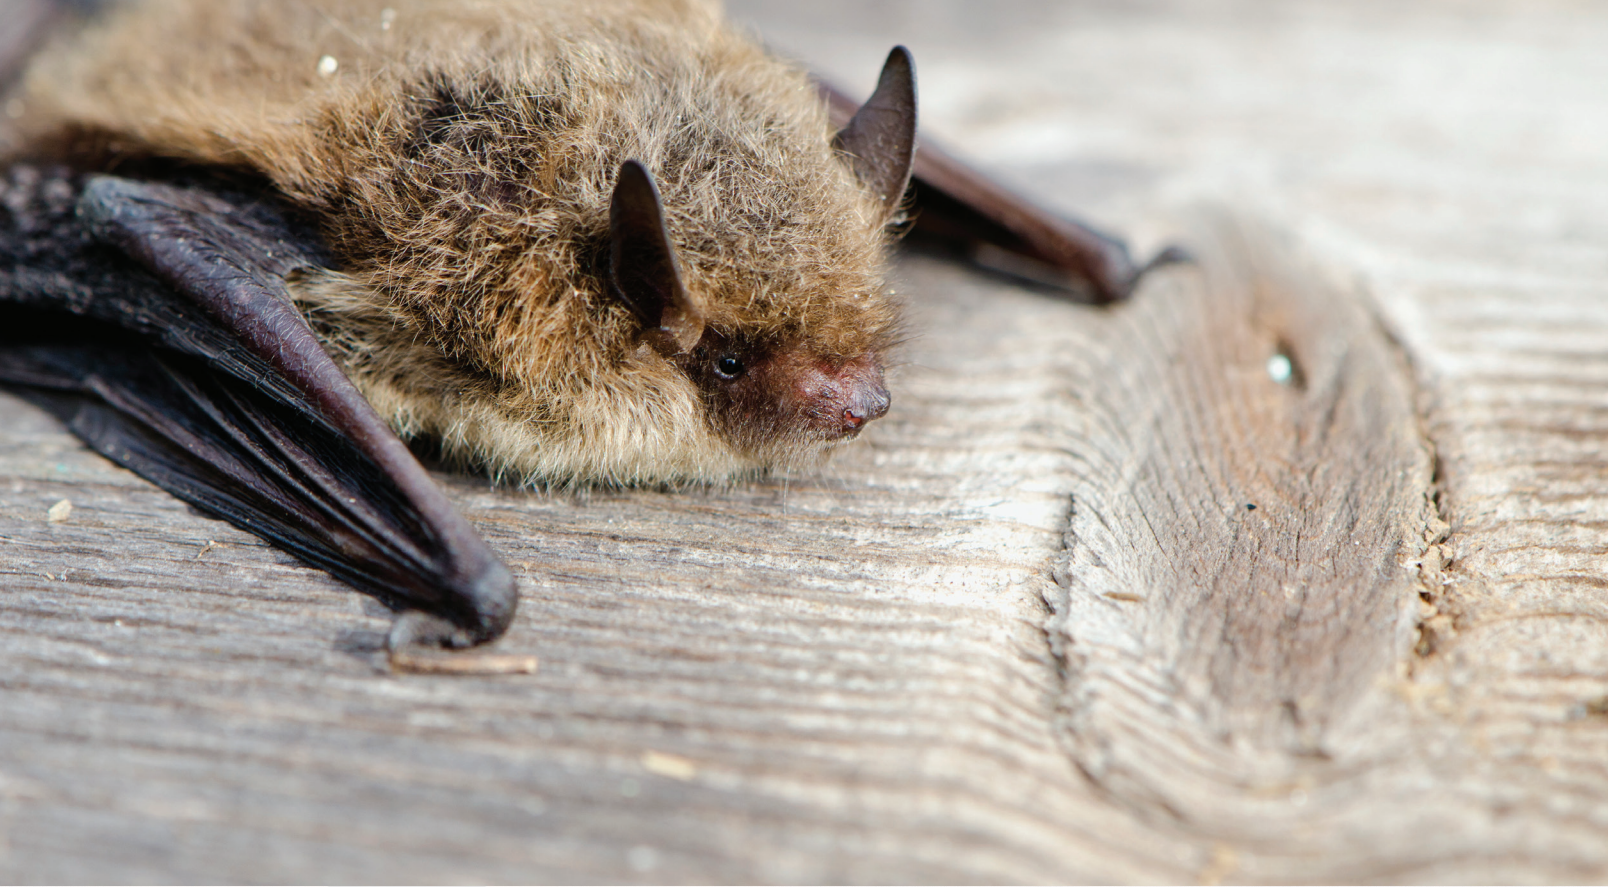
work stops. The bucket trucks and their operators, as well as the biologist, must stop work while supplies are replenished, so it was imperative to track the use of the materials versus the inventory available on-site and ensure the needed items were always on hand. We used backer rod, expandable spray foam, and the clear plastic tubular one-way valves to complete the task. Due to the winter cold, expandable foam and sealant could not be used in the morning hours, and we could not use the products after 3:00 p.m., just in case the bats exited. Bats often “touchback” into the crevices they just exited, and we had to make sure any applied foam or sealant was dry before they might exit in the evening hours. As a result, the sequence of work focused our efforts on placing backer rod into the overhead crevices in the cooler mornings, and any use of expandable foam and sealant took place later in the day, but not beyond 3:00 p.m. The number of one-way valves inserted into the crevices was dependent on the number of bats occupying the crevice.

Once the exclusion devices were placed, we waited two to four weeks for the bats to exit through the one-way valves. The crevices were checked routinely for occupancy by removing the backer rod in the occupied crevices. Once vacated, the one-way valves were sealed with foam and marked as completed with red paint but left in place. Once all the bats were excluded, the team revisited the site to perform routine inspections on the backer rod and repair any areas that worked their way loose until the bridge spans were demolished. The two buffer spans were left undemolished, and these spans had flexible caulk sealant applied since they will remain in place until final demolition of the remaining spans. This will remove the need for routine inspections of the backer rod.
